## WARREN COVERED BRIDGE

### REHABILITATION PROJECT

## ENGINEERING INVESTIGATION AND RECOMMENDATIONS REPORT

NOVEMBER, 2013

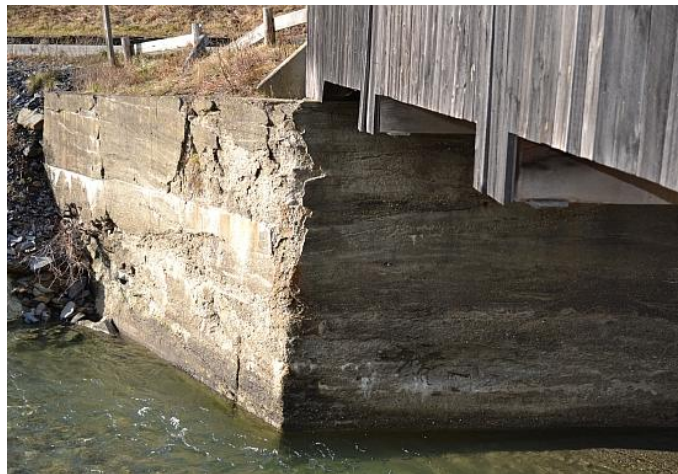
**The West Abutment is in poor condition**

- The abutment is in very poor condition and would require further repairs much sooner than an entirely new abutment
- The abutment is likely not founded on ledge and would be susceptible to scour if/when the downstream dam no longer exists

Several rehabilitation alternatives were considered for the West abutment and other components of the bridge. Replacement of the West abutment is recommended due to its severely deteriorated condition. It is recommended to replace the abutment at its present location because a longer span is not needed hydraulically, and lengthening the span is not practical due to negative impacts to the superstructure. Opinions of probable construction cost were developed for each alternative or recommendation made.

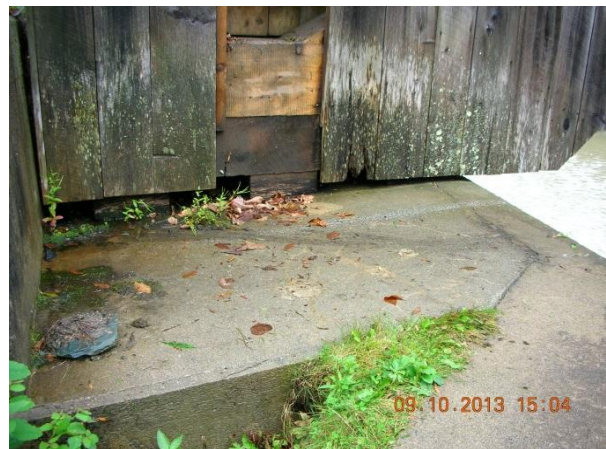
The East Abutment bearing seat cap was observed to have experienced subsidence due to scour and/or settlement. This subsidence has caused water to pond around the bearing blocks and led to their rot. The alternatives to address this issue include:

- i. Replace the abutment bearing seat cap

ii. Repair the abutment bearing seat cap

Included with each East abutment alternative is filling the scour hole at the East abutment with stone fill, and repair of the cracks on the Northeast wingwall.

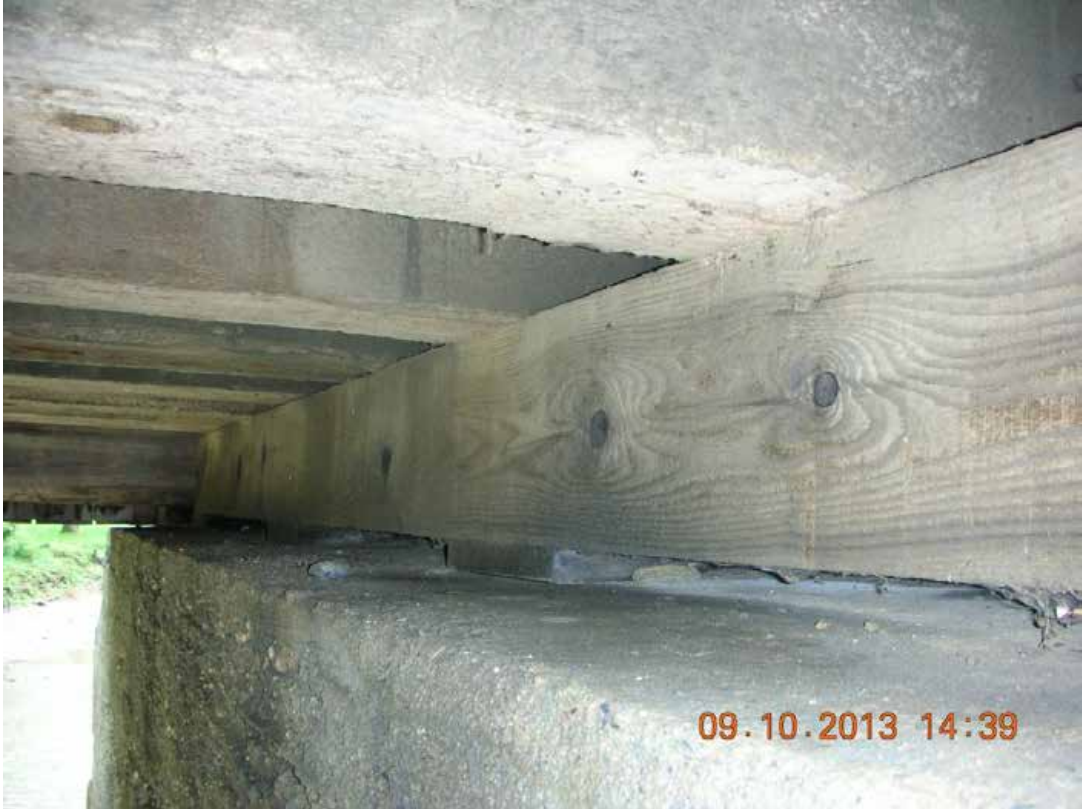
- The bolster beam bearing blocks of the main trusses (3 at each truss bearing, 12 total) are rotting and need to be replaced.
- The stringer bearing beam bearing blocks (4 at each abutment, 8 total) are rotting and need to be replaced.

- Multiple longitudinal stringers have mold on them with 3/16" deep decay at the ends. Holes in one of the stringers indicate insect intrusion. There is a heavy check in one of the stringers near mid-span. These stringers should be evaluated for existing condition capacity and may require replacement.

Photograph 5 - Ends of Stringers and Stringer Bearing Beam

- Replace bearing beam bearing blocks (8 total)
- Replace 9-foot length, 4-foot height of siding at each of the four corners of bridge
- Replace two (2) rotted stringers at West end bay
- Evaluate capacities of decayed stringers to ensure load capacity, shave off decayed portions to prevent further moisture penetration
- Replace roadway pavement and subbase within limits of disturbance
- Signing for the bridge should be replaced to meet current MUTCD standards
- Remove and replace approach railing with either timber or steel beam approach railing. At a minimum, the guardrail approaches to the West abutment will need to be removed and reset with the replacement of the abutment.

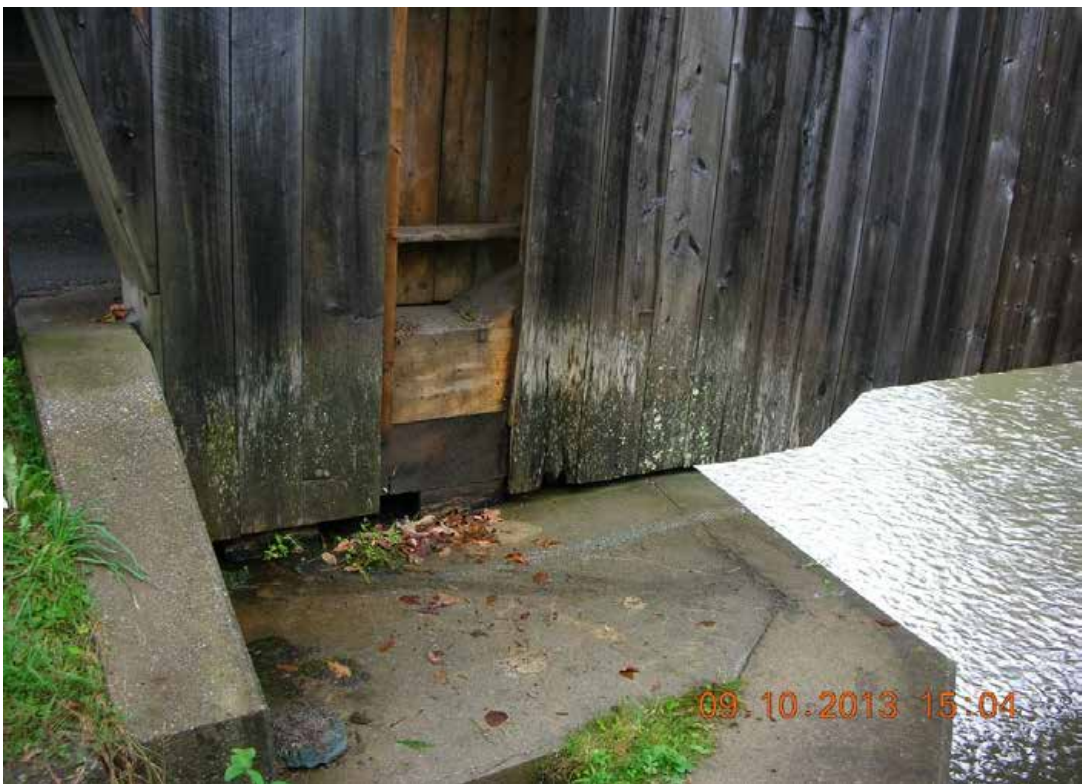
Photograph 6 - East Abutment Bridge Seat and Bridge End

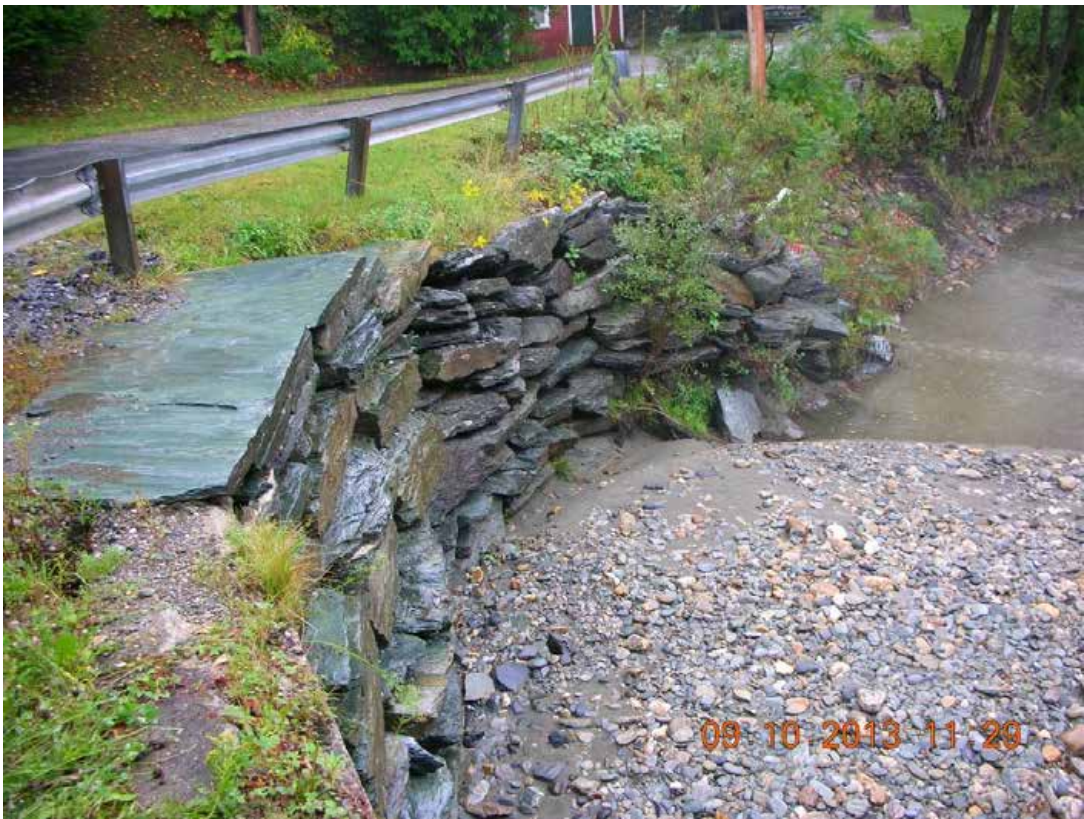
The downstream retaining wall on the West side of the river is in poor condition and in need of repair. At a minimum, a portion of the stone wall will need to be removed and reset due to the excavation required for the new abutment wingwall. Alternatives considered for the downstream retaining wall include the following:

The majority of the wall length has shifted or moved, and is significantly out of plumb. This alternative involves removing the entire length of wall and resetting the wall properly in-place. Although the wall will not be of the construction that a new, engineered concrete wall would be, the wall will be plumb and in a more stable condition than it is currently.

Photograph 9 - Retaining Wall (Downstream Side, West Bank)

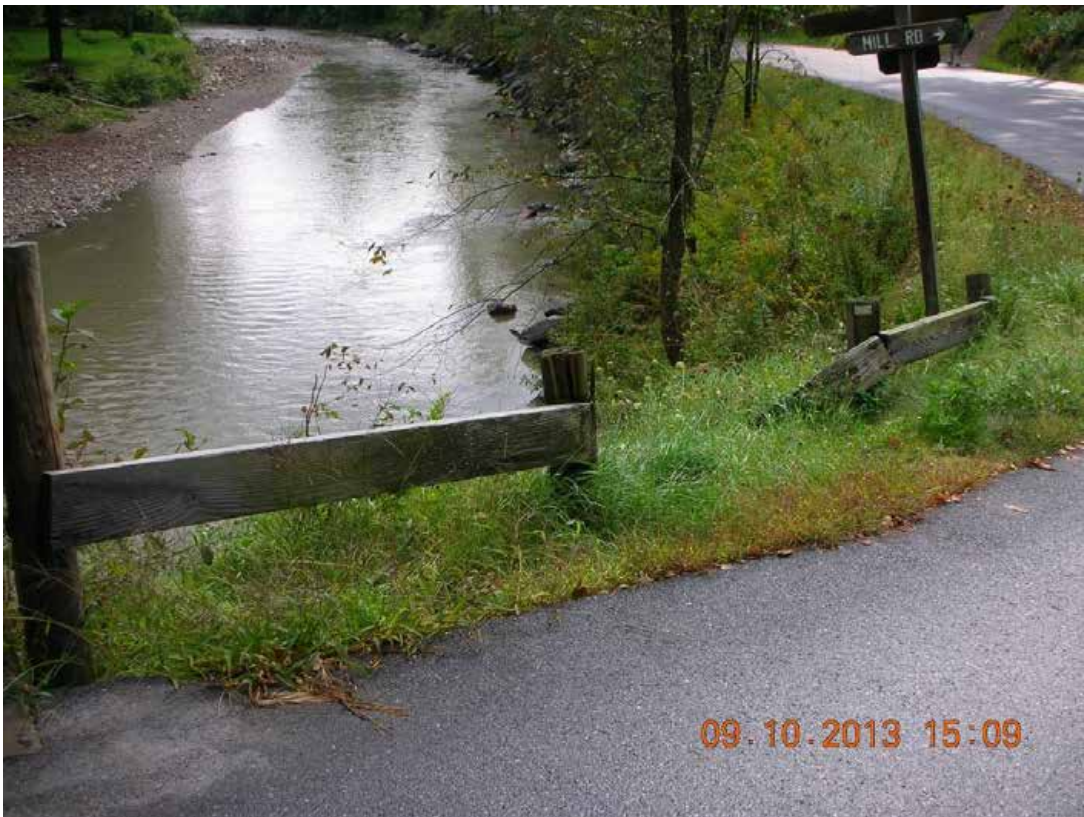
- The approach rail at all 4 quadrants is substandard.
- The Northeast wingwall has cracks and discoloration (approx. 1.5 ft. x 10ft.).

- The alignment is poor for modern day traffic
- The rail at the Southwest corner is rotten and broken. The steel beam rail at the Northeast corner has been removed
- The transverse planking has some leakage and staining with soft rot, but decay is minimal
- The stringers may have some decay at the abutment ends
- Oak bearing blocks are rotten. Only the front blocks are in bearing at each corner
- The cedar shingle roof has many holes where the shingles are degrading, especially along the south side exposed to sun
- The West abutment has areas of degradation with scaling and delamination
- The Southwest wingwall has heavy scaling and some break up
- General scour exists with some exposed ledge

Photograph 10 - Substandard and Damaged Approach Rail at SW corner

- Replace West abutment with new exposed-face, MSE type abutment and wingwalls, on cast-in-place concrete pad bearing on bedrock, located in the position of the existing abutment
- Repair east abutment bearing seat cap by pumping grout under the base
- Fill scour hole at east abutment and repair cracks on the northeast wingwall
- Remove and replace downstream, West bank retaining wall only in immediate disturbance area
- Replace cedar shakes on north side of roof
- Replace bolster beam bearing blocks of main truss (12 total)
- Replace bearing beam bearing blocks (8 total)
- Replace 9-foot length, 4-foot height of siding at each of the four corners of bridge
- Replace two (2) rotted stringers at West end bay
- Evaluate capacities of decayed stringers to ensure load capacity, shave off decayed portions to prevent further moisture penetration
- Replace approach railing and signing
