VERMONT HERITAGE

Covered Bridge Brigade

When your town's historic covered bridge breaks, who can be called in to fix it?

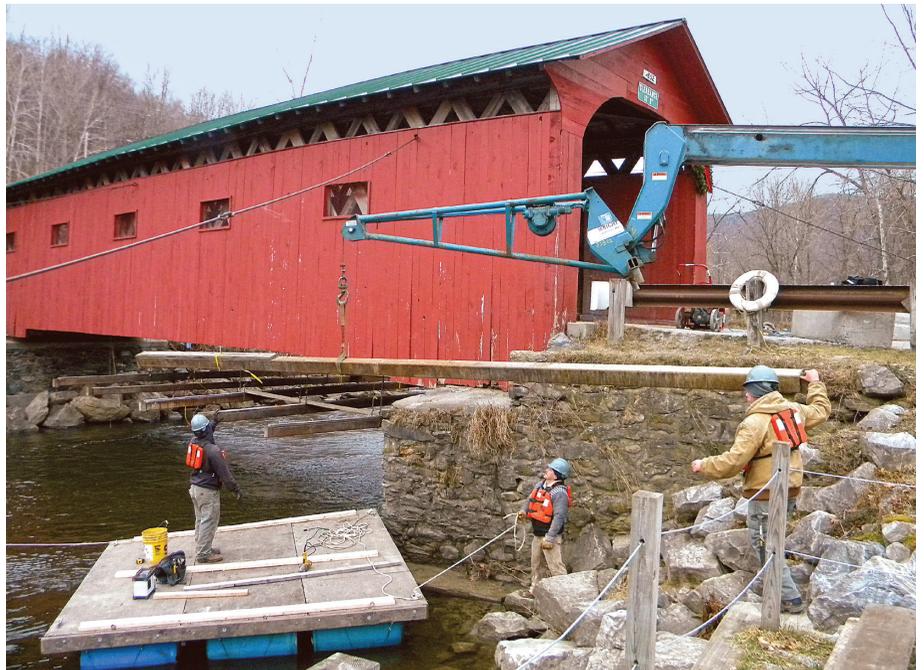
On January 25, 2012, the three-man crew from Wright Construction was hard at work, using a raft to serve as a temporary platform from which to hang scaffolding under the bridge. The damage inflicted by Tropical Storm Irene the previous August was apparent (below) in the outward bow in the downstream side of the bridge.

Once the raft was neatly swung into position under the bridge to provide a working, albeit floating, surface, scaffolding was slung from the bridge's 160-year-old underpinnings to make a temporary bridge on which the workmen could stand. Despite the coldest weather Mother Nature could dish out, Rich, Miguel, and Justin worked from 7:00

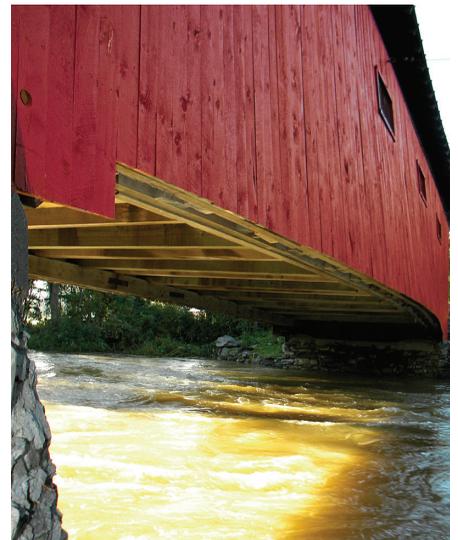
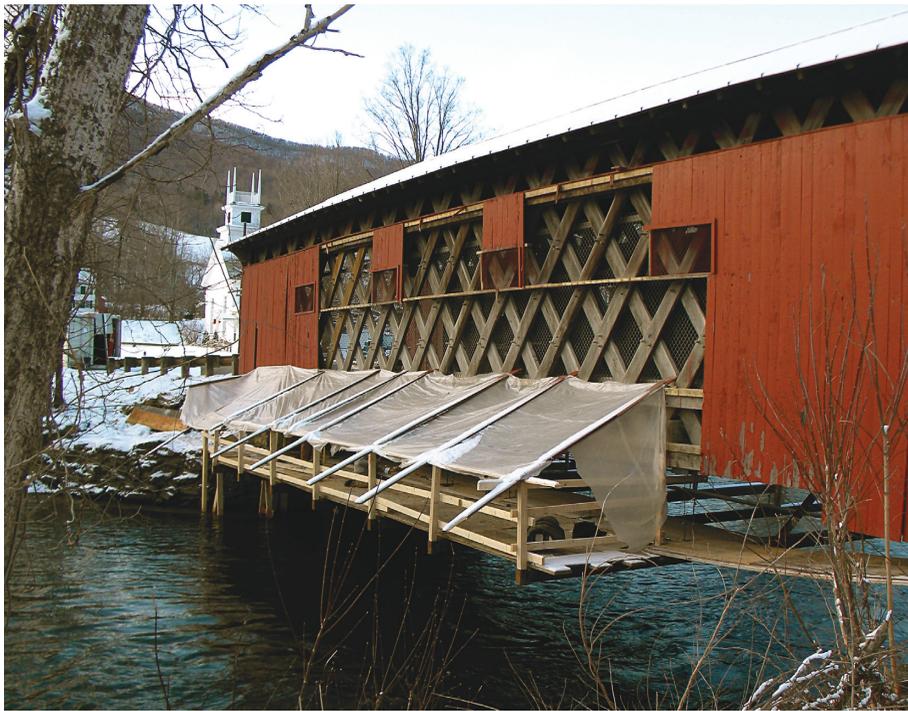
By January 30, parts of the bridge siding had been removed to gain access to the trusses and chords of the bridge. Plastic was used to cover scaffolding and provide protection from the weather as work progressed both under and on the upstream side of the bridge.

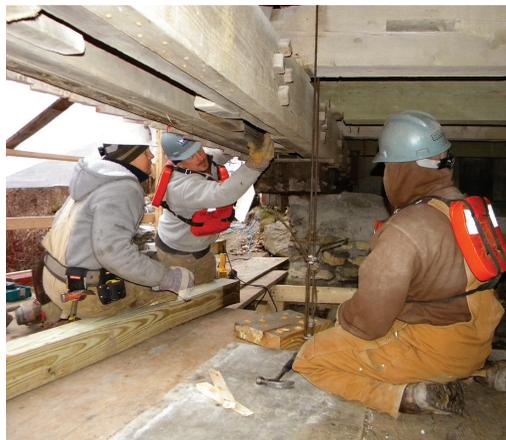
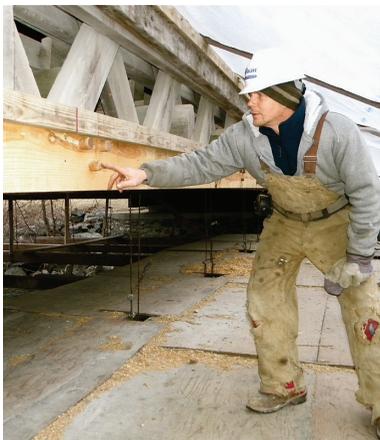
Project Superintendent Rich Butrimas points out one of the new oak pegs, or trunnels (also known as tree nails), used as fasteners. This is the traditional methodology of the covered bridge builder and used in securing the new section of the lowermost chord that has been grafted in.

By mid-February, the two broken sections of the D span had been removed, their replacements grafted into place and secured with new oak trunnels, and the bridge had been pulled gently back into proper place on its abutments with the use of a come-along and chains. With the know-how of covered bridge chiropractors of sorts who fix one problem at a time, the crew gingerly passed a long, threaded steel rod through the structure's south end. The rod's downstream end was secured to the bridge's exterior and a steel plate secured with a threaded nut on the upstream side's exterior. A large wrench and muscle power to carefully turn that nut with it then slowly brought the bridge back into proper alignment and true shape, a process that took eight days. "My job was to realign the bridge onto its bearings," explains Rich, "from where the shock of impact pulled the floor."

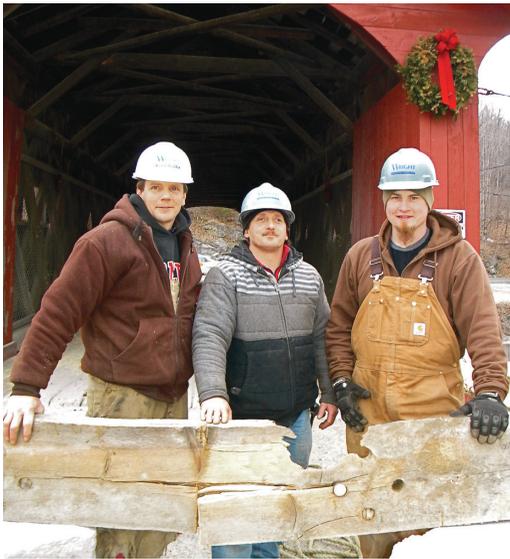
Almost all of the repair work performed on site was done by just these three men. From left to right are Project Superintendent Rich Butrimas, foreman Miguel Salo, and carpenter Justin Ackley posing on February 16, 2012 with the storm-damaged portion of the lower bridge chord they had replaced. The bridge was opened to traffic not long after this photo was taken.

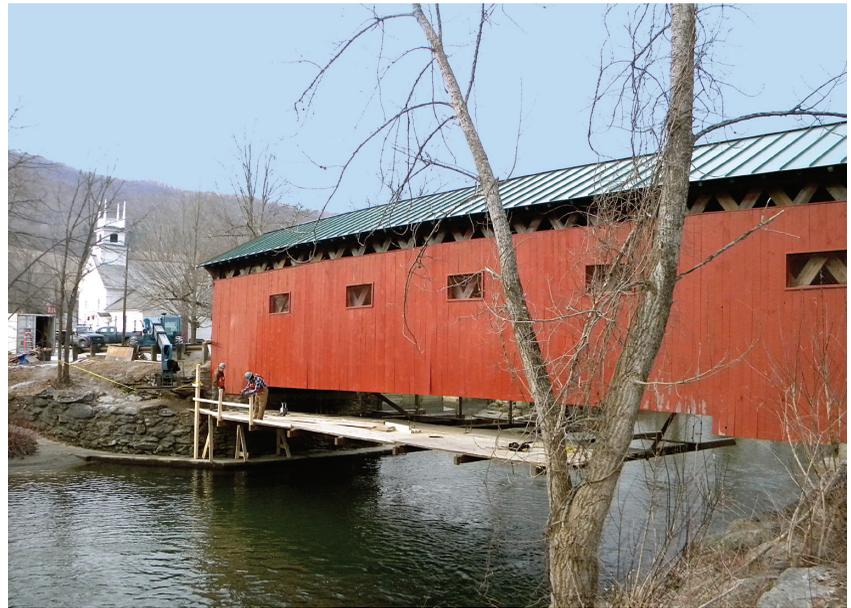
With new siding (that had been pre-painted in Wright Construction's shop) installed, the crew was busy taking down scaffolding when this photo was taken the day before the bridge opened to traffic.

Inside the bridge, a carpentry shop had been set up; saws powered by a portable generator buzzed away as wood was cut for final details of the repair. New siding, the finishing touch, had been pre-cut and pre-stained in Wright Construction's shops and was installed by February 15, the date the crew began to dismantle the scaffolding. On the very next day, February 16, the job was finished and West Arlington's historic covered bridge was open to traffic once more.

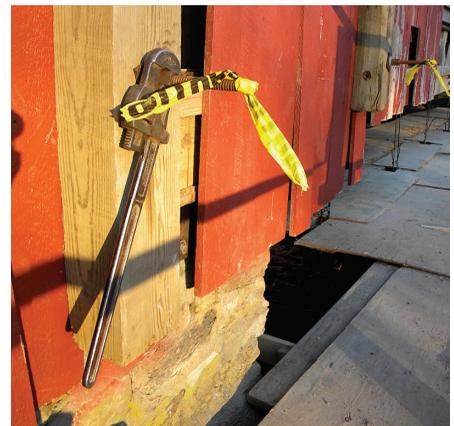
Before the new siding went on, a king-size wrench was used to slowly turn a nut on a threaded rod that ran through the bridge and pull it gently back into proper alignment. The entire process took eight days.

A roughshod method that the uninitiated repairman might have used "like what some guys did years ago," Rich points out, "might have meant hitching the bridge up to a tree on the shore and then just yanking the bridge upstream; you can't do that. The bridge got hit in the middle...so, there's some memory in

those chords. You can't twist a bridge back onto its bearings."
