# THE BRIDGER

The Vermont Covered Bridge Society Newsletter – Issue #89

### Executive Summary

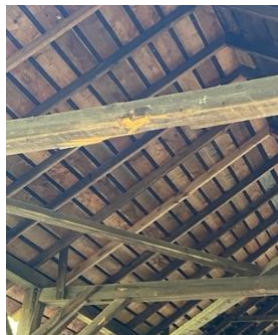
The Red Bridge in Sterling-Morristown was damaged in 2021, when an oversized box truck pushed its way through and damaged the tie beams. Two beams look just scraped, while one has damage on both sides.

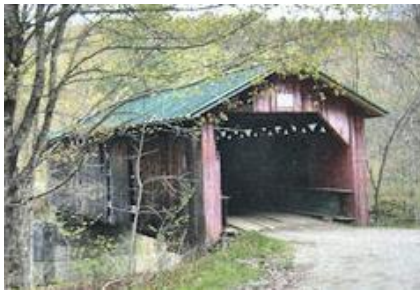
The Hutchins Covered Bridge was inspected and load rated to determine its current condition. Our rating assumes replacement of deteriorated bridge members. It was determined that at the inventory stress limit, the existing trusses have a live load capacity of approximately H7.8 (7.8 tons), the floor beams have a capacity of H4.2 (4.2 tons), and the deck has a capacity of H7.2 (7.2 tons).

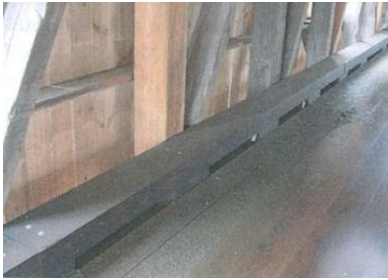
The existing floor beams and decking were analyzed to determine their live load capacity. The deck capacity was determined to be H7.2 (7.2 tons), assuming a No. 1 grade. The floor beam capacity was determined to be H4.2 (4.2 tons) for a No.1 grade at inventory and H5.9 (5.9 tons) at operating.

Based on the condition of the deck and floor beams and an H6.0 (6.0 tons) live load goal, we recommend complete replacement of the floor beams and decking with new sawn members of approximately the same size. The species of the new members would be Douglas Fir or Southern Pine to meet the H6.0 (6.0 tons) live load requirement. If H20.0 (20.0 tons) live load capacity is required, glulam decking and floor beams would be required as discussed above. In addition, we recommend that a new wood curb be added to the bridge to help keep vehicles from impacting the trusses and knee braces. This curb has previously been used by VTrans on the Union Covered Bridge in Thetford, the Comstock Covered Bridge in Montgomery, and the Greenbanks Hollow Covered Bridge in Danville.
